Starlight Mesa Hillside Maintenance Policy

Preface

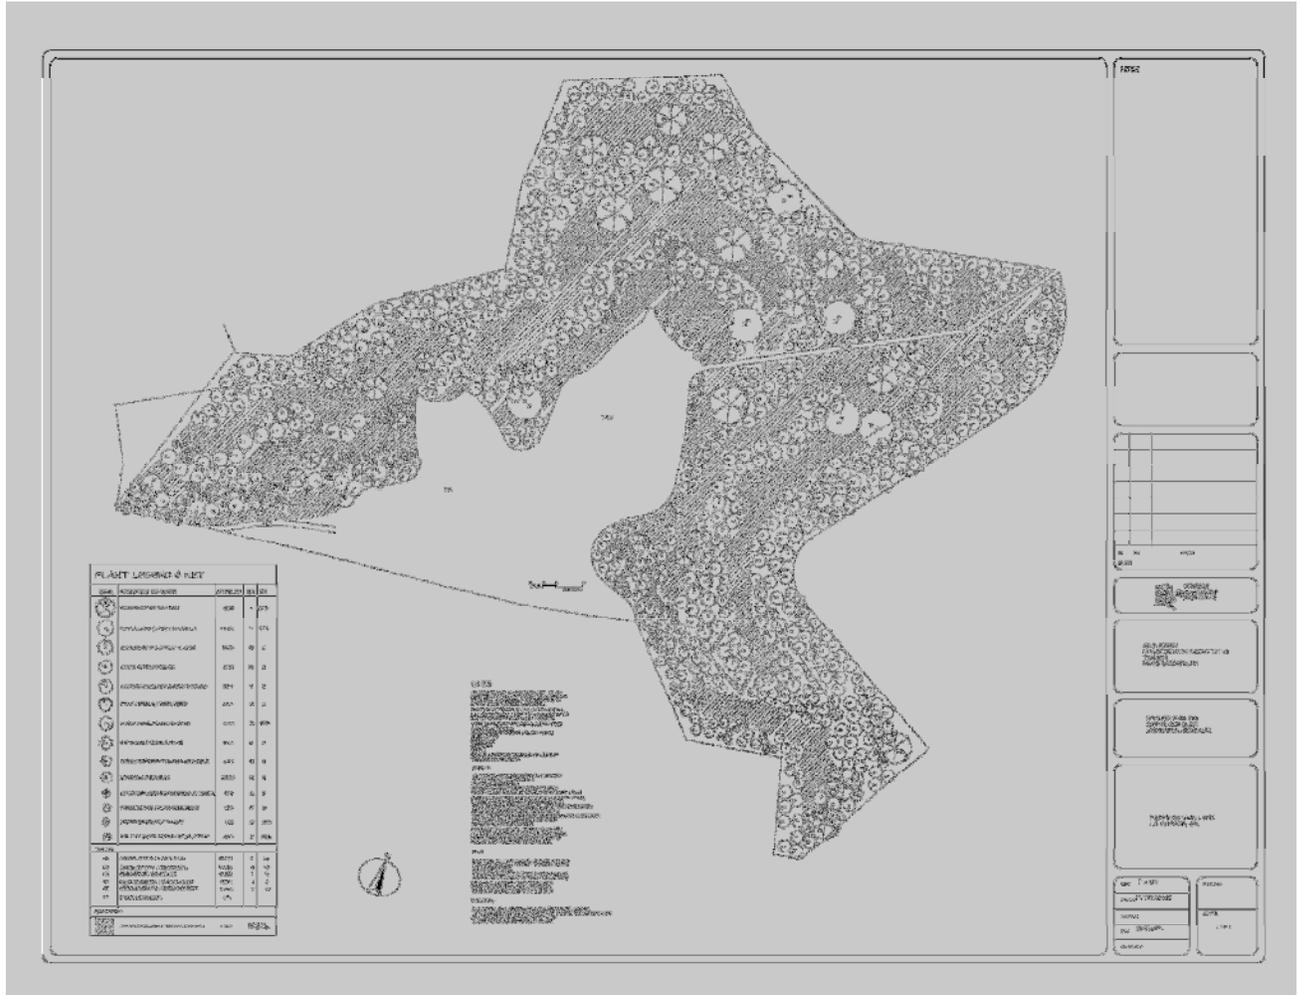
Appendix F

Click here for higher resolution of this landscape plan—
[http://starlightmesa.org/Starlight Mesa hillside planting v.2 2-16-09.pdf](http://starlightmesa.org/Starlight_Mesa_hillside_planting_v.2_2-16-09.pdf)

The policy established herein will try to unify the treatment of this area. These hills surround our largest common assets, the pool and tennis court. The board retained Argia Designs, a native plant landscape design firm, to create a multi-year plan to convert these hillsides to native, fire resistant, low or no water plants. See appendix F. The criteria for selecting plants and creating the design were fire safety, erosion control, low water usage and beauty. This plan is portable to future boards.

The design plan calls for a mixture of shrubs, trees and groundcovers that vary with the compass settings of slopes. A southward facing slope will not be planted in the same manner as an eastward. The design will incorporate proper spacing for fire breaks.
